NBSIR 84-2858 (R)

Report No. 11

Observations of the April 8, 1979 Railroad Accident at Crestview, Florida

U.S. DEPARTMENT OF COMMERCE
National Bureau of Standards
Center for Materials Science
Washington, DC 20234

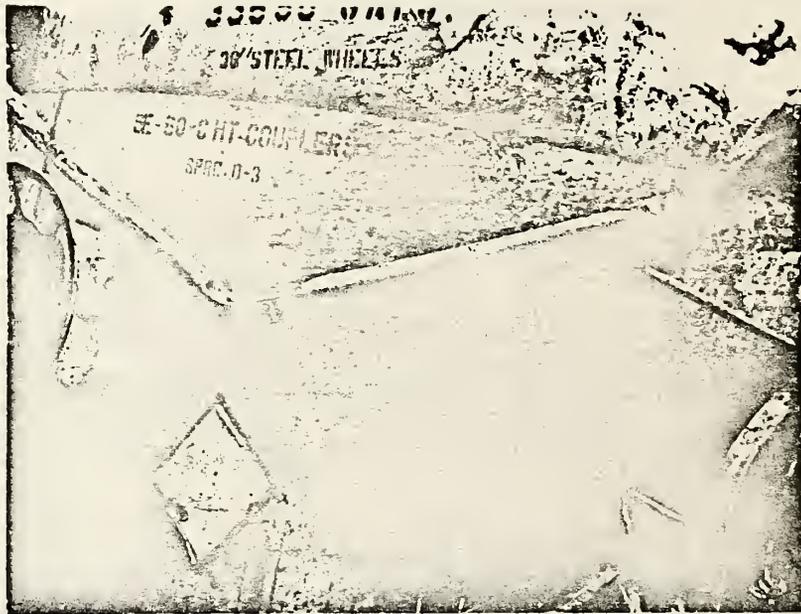
Sill, Coupler, Wheel, other parts (in that order) Head shield support pad (see 2-2) and head shield (2-3 and 2-4). Head shield was hit from one side with a gentle crushing force. Damage is shown in photos.

Photo 2-3: B head showing the head-shield of tank-car GATX 93444.

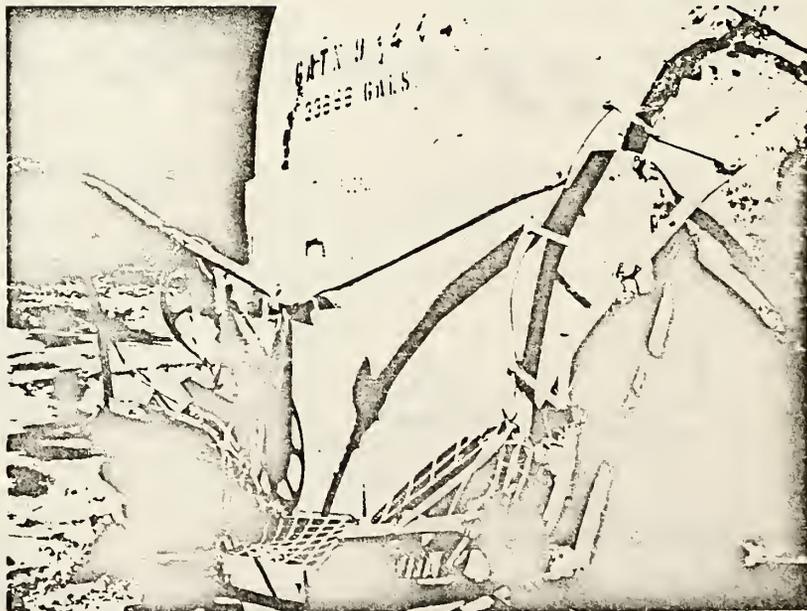
Photo C1-9: B head showing the head-shield of tank-car GATX 93444.

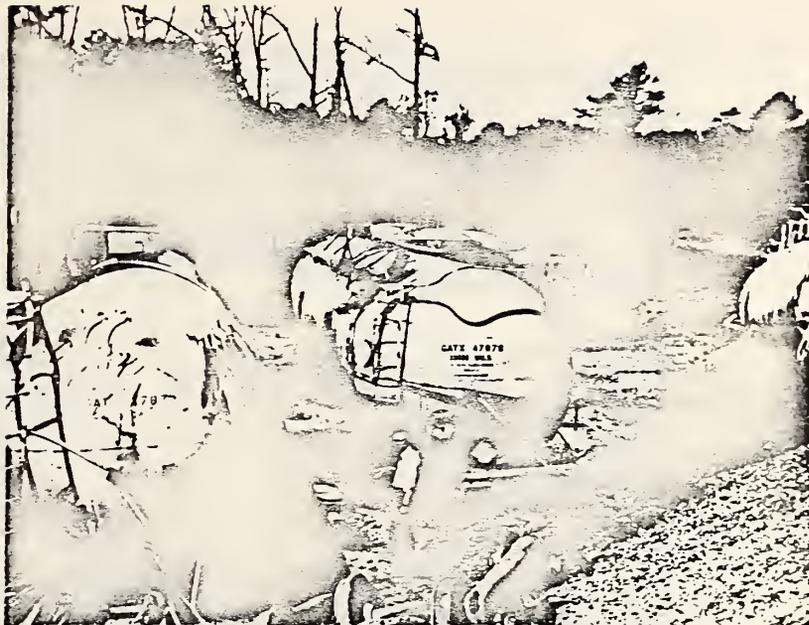
Jacket: No Jacket _____ or Describe: Dented and scratched, and ruptured (see 1-8 and 1-8B) in head (small) and shell area (larger).

Photo 1-8: Tank-cars GATX 47878 (right) and GATX 47872 (left).

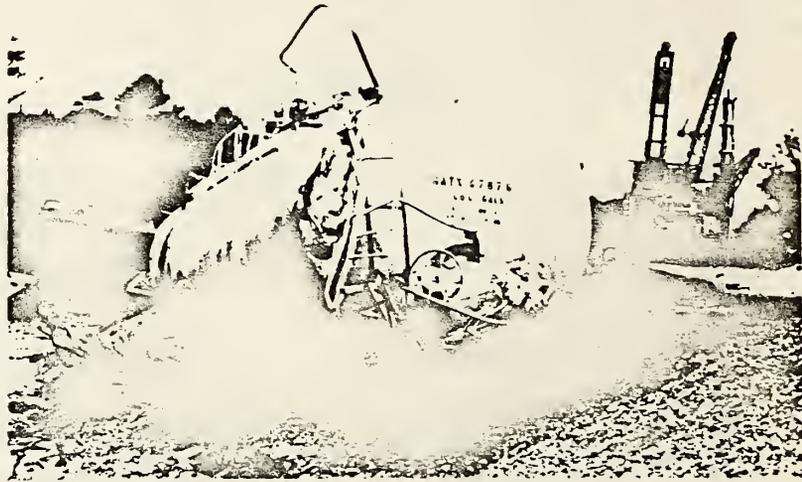
Photo 1-9: B head of tank-car GATX 47876.

Jacket: No Jacket _____ or Describe: Damaged at one end. Both A and B-heads jackets have dents at edge.

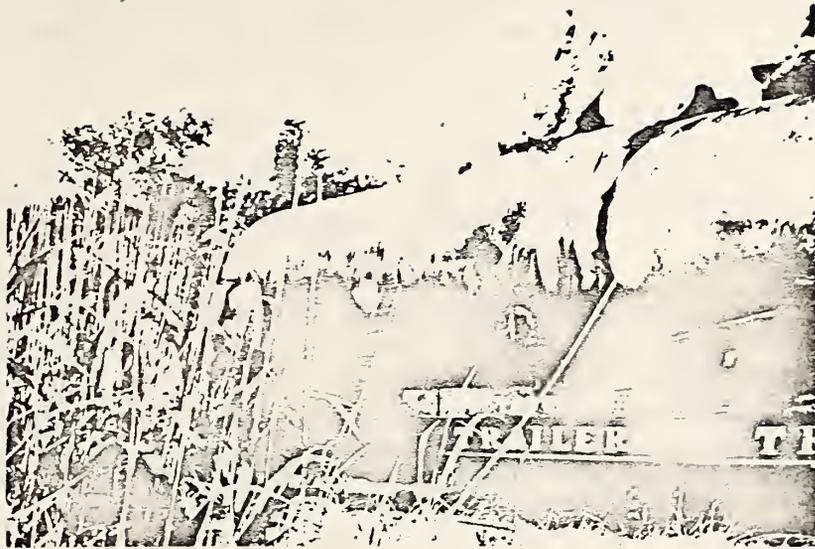
Shell and Head Plates: The leaking shell course had a hole punched in
it just below the middle of the shell course.

Photo C4-19: Tank-car UTLX 28727 showing a hole in the center shell course.

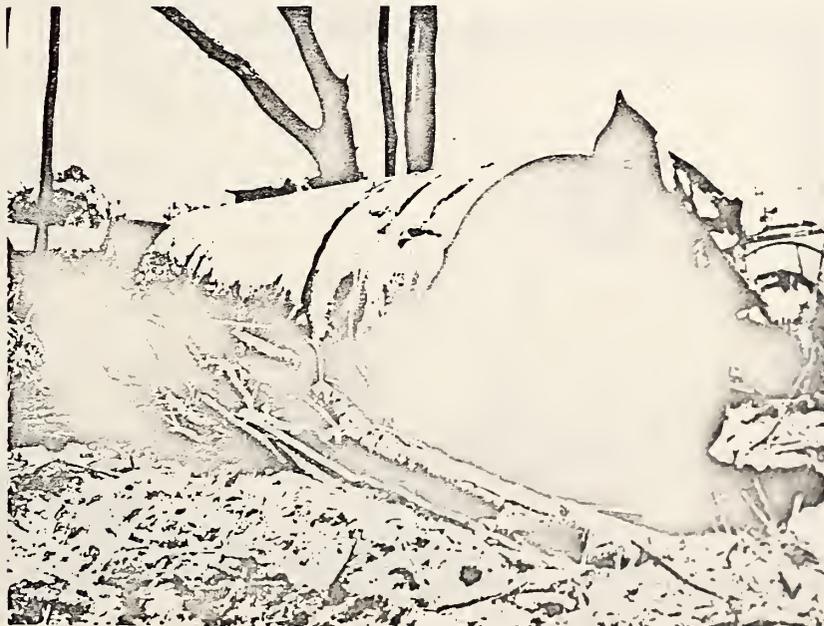
Photo C2-18: North side tub (B-end) of tank-car
IMCX 2827.

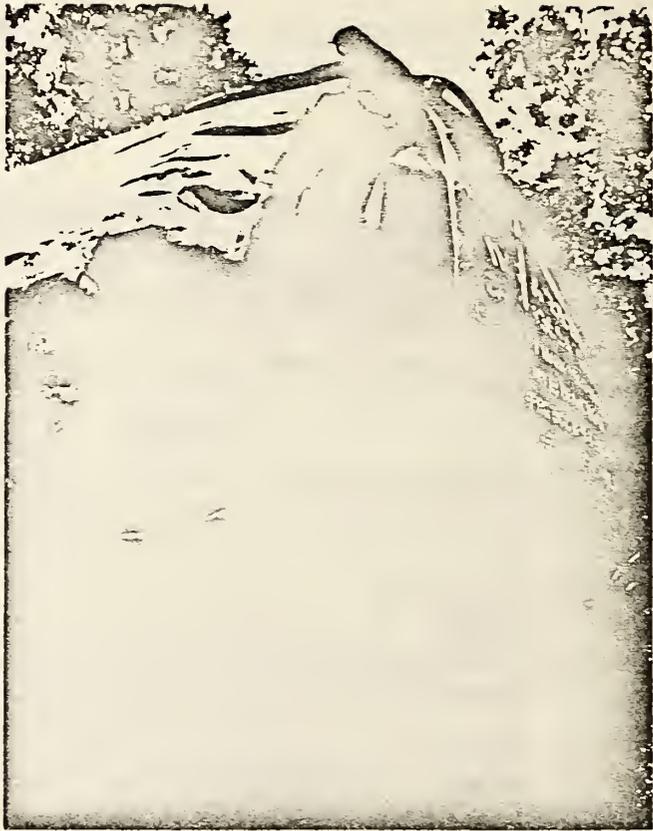
Photo C4-5: B head of the north side tub of tank-car
IMCX 2827.

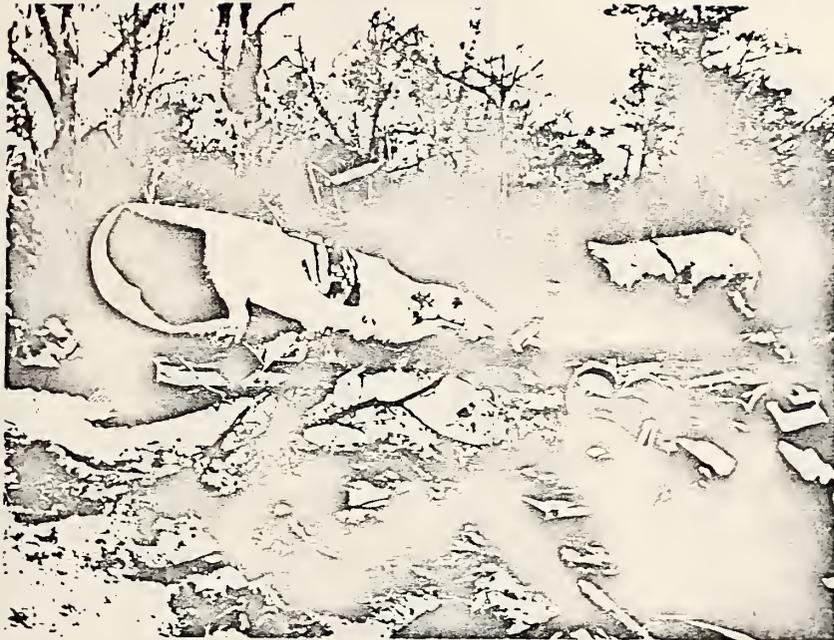
Photo C3-12: South side tub (A-end) of tank-car
IMCX 2827 (right) and tank car ACFX
82959 (left).

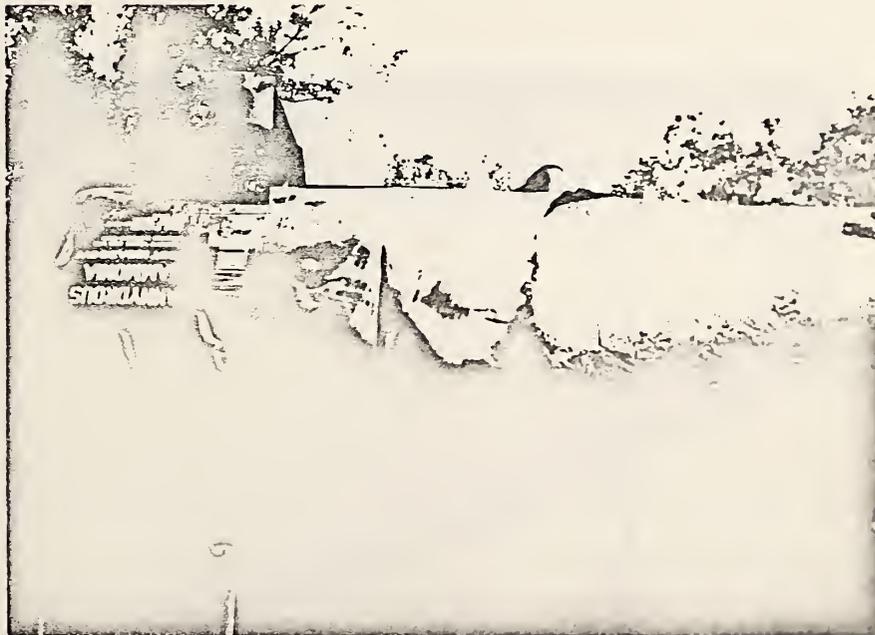
Photo C4-6: South side tub (A-end) of tank-car
IMCX 2827 being carried in a gondola car.
